Resource Recovery Centre, Ringaskiddy, Co. Cork

Coastal erosion report addendum: Assessment of the December 2015 slope instabilities

WM/REP/0002

Issue | 19 April 2016

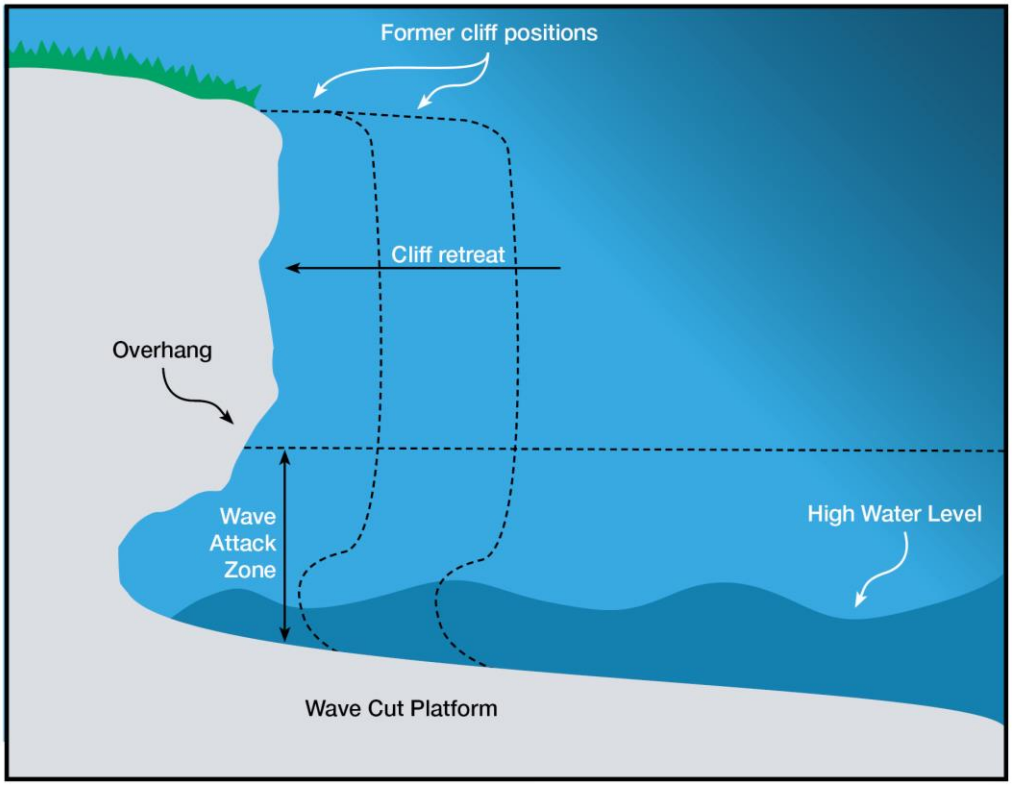
The impact of sea erosion on the recently slipped slopes appears to be minimal. In general the sea action in storm conditions erodes the face of the slopes within the tidal range, leading to the creation of cliffs (steepened slopes) and ongoing slip failures (see Figure 13 below). These over-steepened slopes are unstable in the long-term, but remain steep due to the erosion mechanism which effectively removes ‘slices’ of cliffs over time.

Figure 13: Typical steepened cliffs eroded by wave action

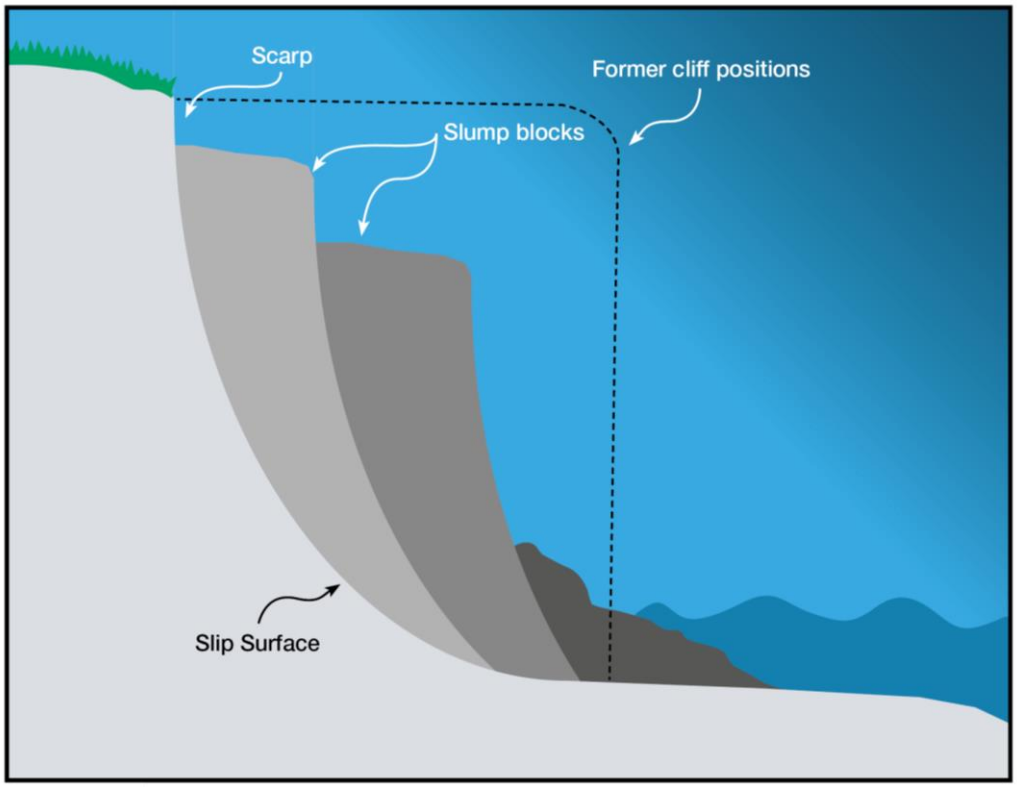
The photographs show that where tallest and steepest, the cliffs are predominately boulder clay soils with some minor local gravelly lenses. Where the recent slips have occurred there are significant deposits of sands. The presence of these sand deposits (lenses), and the 'flatter' or more circular slip surfaces observed, with significant flow of water through the face of the slips, clearly indicates failure due to infiltration of surface water (See Figure 14 and Figure 15 below). A circular geotechnical failure like that causes a larger retreat in the cliff than the 'slices' of cliff eroded by wave action.

Figure 14: Typical slope failure showing circular slip surface

The evidence observed on site shows that the recent slope failures are due to the effects of the excessive rainfall over the month of December. While sea erosion is a contributing factor to erosion along this section of coast, the recent slips were triggered by water pressure and flow within the cliff material causing instability and slip failure.

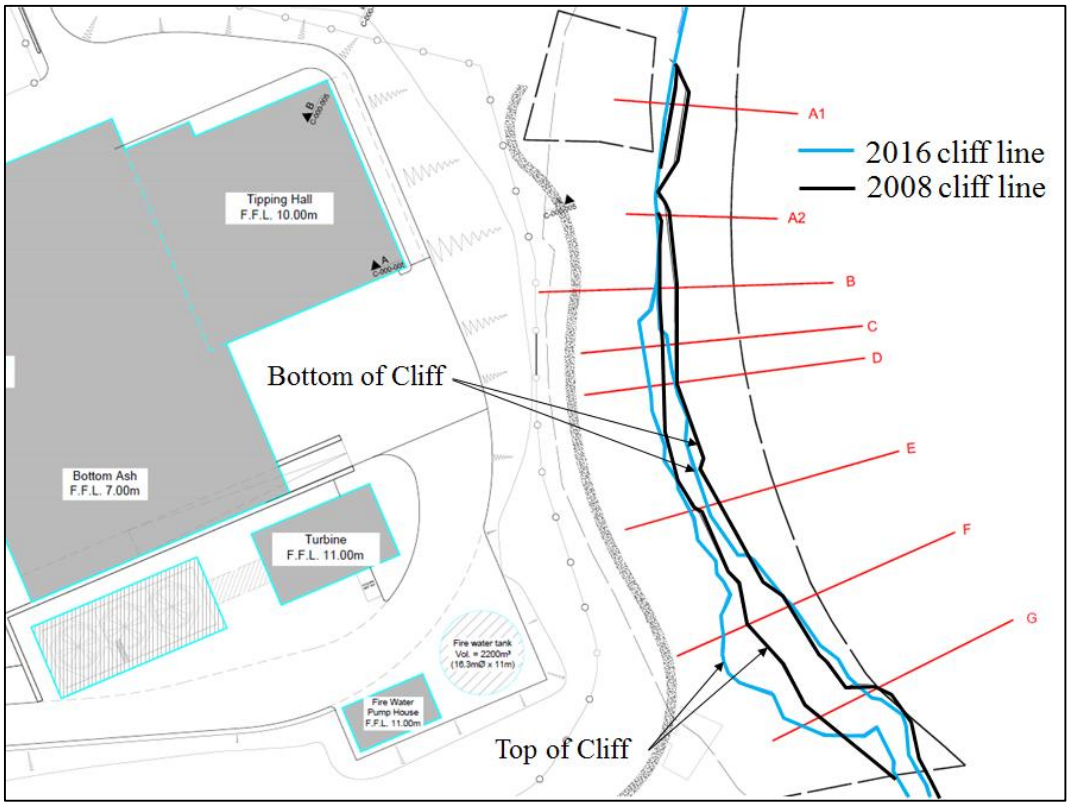
Figure 17 shows sections A1 to G as well as the top and bottom of the cliff as derived from the 2008 and 2016 surveys. This figure shows the approximate locations of the two slope failures mentioned previously. The smaller slope failure located south of the car park is located roughly between sections B and D and the larger slope failure is located roughly between sections F and G.

From Figure 17 it can be seen that the bottom of the cliff line has remained relatively stable in comparison with the top of the cliff line. At the location of the larger slope failure in the south, the bottom of the cliff line has actually advanced since 2008. This is likely due to the presence of the slumped material from the upper cliff. The relative stability of the bottom of the cliff indicates that the toe of the cliff has not been affected to a large degree in recent years by erosion due to wave action.

Figure 17: Sections A1 to G showing top and bottom (toe) of the cliff from 2008 and 2016 surveys

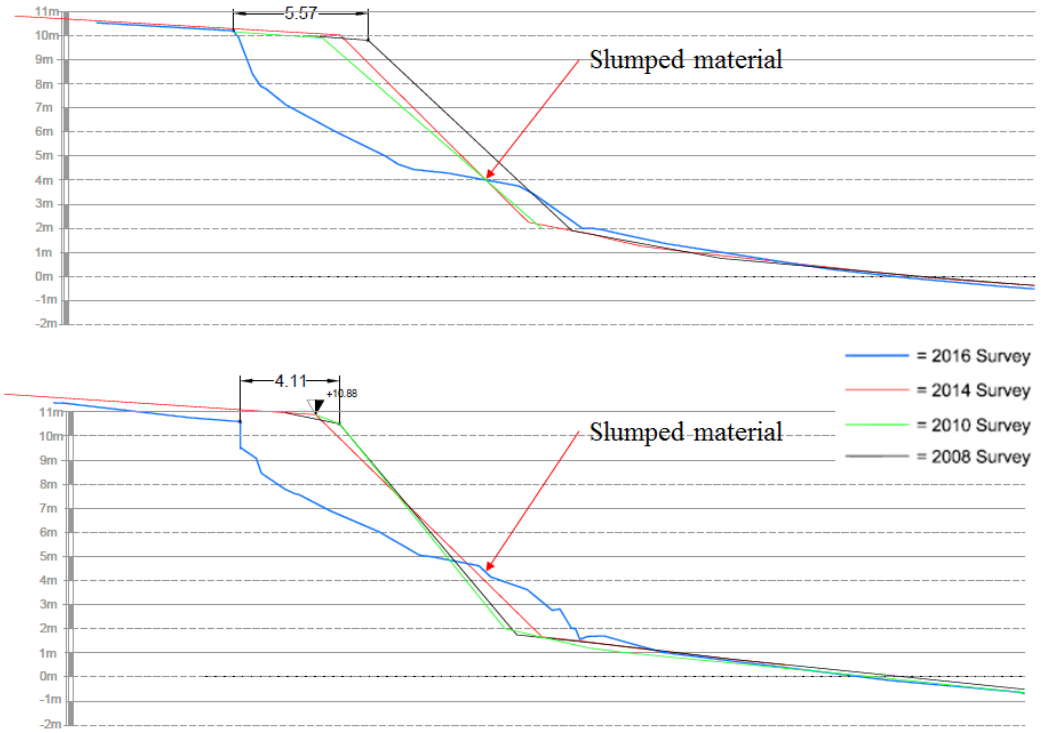
When comparing the topographic surveys from 2008 to 2016 it becomes obvious that the location of the largest slope failure was between sections F and G with a smaller collapse located between sections B and D. Figure 18 below shows an extract from the section drawings for sections F and G. The largest retreat of the top of the cliff between the 2008 and 2016 surveys was localised between sections F and G, with a value in the range of 7-9m.

- The upper section of the cliff has slipped with the debris accumulating at the toe of the cliffs
- Between 2008 and 2014 there has been little erosion in this area
- The toe of the cliff has remained stable i.e. has not been eroded significantly
- Beach levels have remained stable in recent years indicating that the foreshore/ beach has not been eroded during recent events

At the localised slope failures the fact that the toe of the cliffs and the foreshore/ beach levels have been largely unchanged between 2008 and 2016 would indicate that erosion by wave action has not been a significant issue recently. This confirms the findings of the site walkover i.e. while sea erosion is a contributing factor to erosion along this section of coast, the recent erosion events were due to water pressure and flow within the cliff material causing instability and slip failure rather than erosion due to wave action alone.

Figure 18: Sections F and G showing survey information from 2008 to 2016
