ORAL HEARING

RESOURCE RECOVERY CENTRE,
RINGASKIDDY, COUNTY CORK

WITNESS STATEMENT OF JULIE ASCOOP

COASTAL EROSION

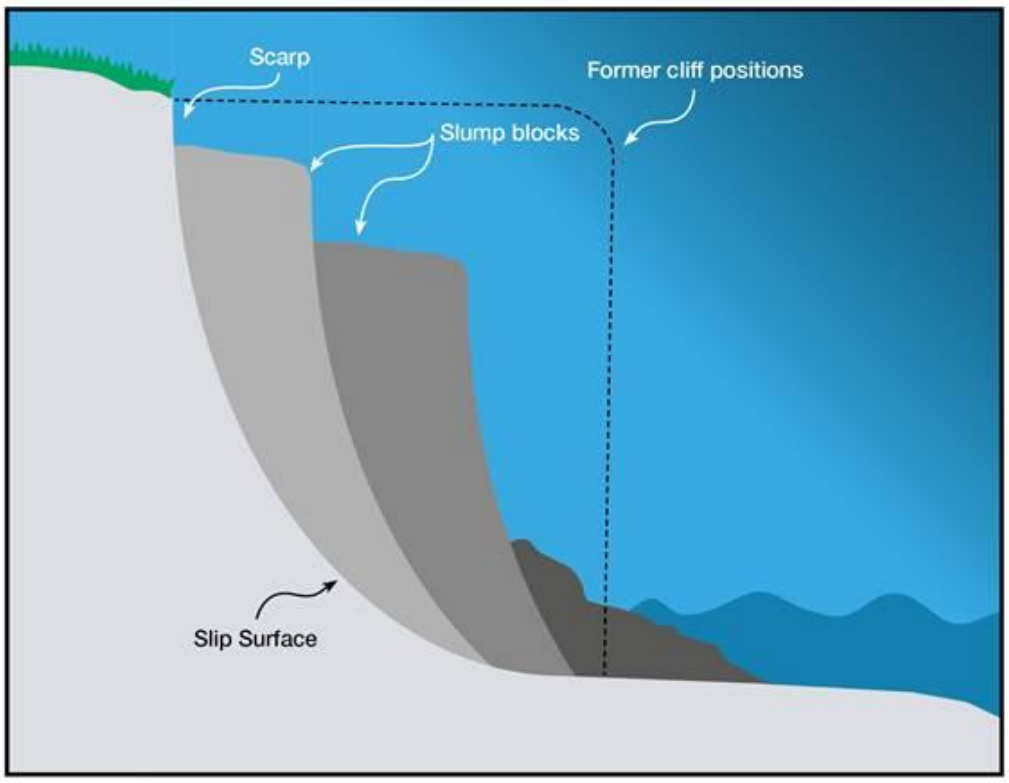
Figure 1: Typical slope failure showing circular slip surface

- Two slope failures. The first one approximately 50m south of the car park was limited in extent. The second slope failure, further south, was larger and V-shaped back landward. A significant amount of material had slumped down in the second failure.
- Water running out of the face of the cliff in the failure zones, even though there had been no recent rain. In the larger failure, a small stream (of fresh water) ran out from the face and flowed into the sea.
- In the larger failure, sand lenses were observed in the mainly clay cliff face.
- There was no evidence of any significant notching at the bottom of the cliffs on either side of the failure zones and the beach shingle was high up on the beach covering the toe of the face.

Assessment of the situation on site, and the topographic survey showed that the slope failure was most likely triggered by the significant rainfall causing excessive water pressure and flow within the cliff material, which caused instability and a localised geotechnical failure of the slope.

The presence of sand deposits, and the less steeper angle (compared to the slope of the face where failure had not occurred) or more circular slip surface (see image below), with significant flow of water through the face of the slips observed at the failure zones, all point in this direction.

There is no evidence that one mechanism makes a greater contribution than the other. As shown in the image above, Figure 1, the geotechnical slope failure is likely to cause a bigger slip circle but would occur less frequently than the smaller slides caused by the 'notching' of the cliffs due to wave action.

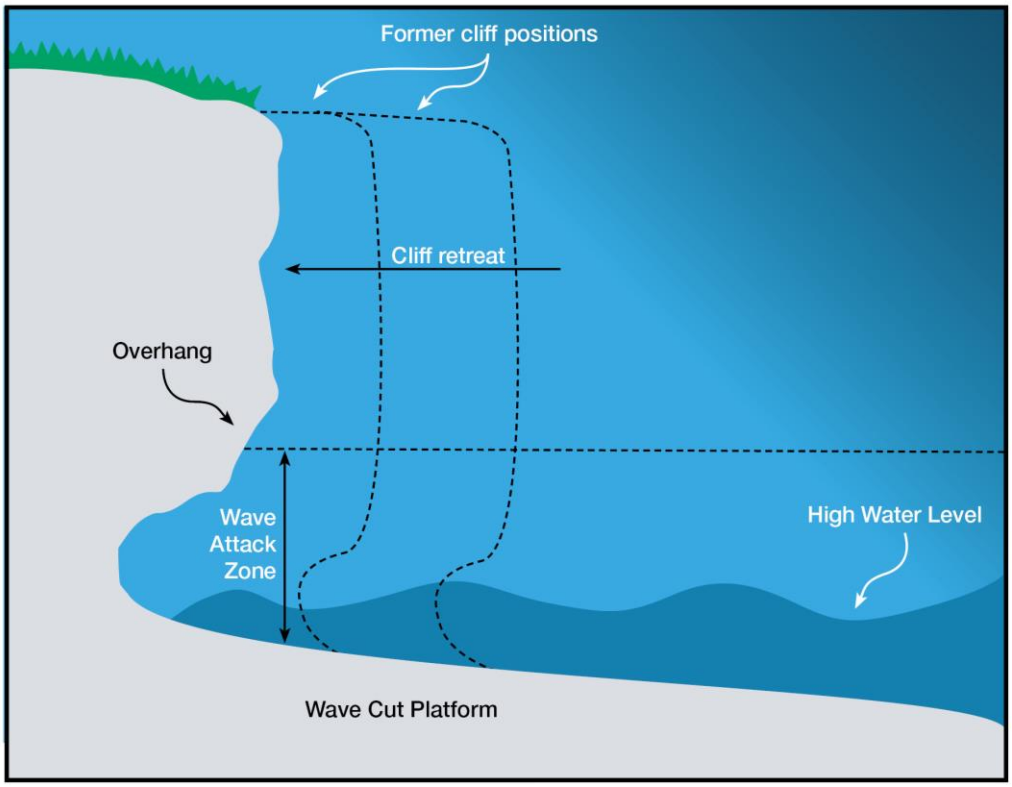
Figure 2. Typical steepened cliffs eroded by wave action

The December 2015 failure confirms the assessment (see Appendix 13.3 of the EIS) that the cliff recession has both a geotechnical and a coastal element. The coastal impact was confirmed by our numerical wave modelling studies and wave run- up assessment which show that waves reach the bottom of the cliffs. We also have seen evidence on site of typical 'notching' of the cliffs caused by wave attack (see figure 2 and 3 below).

flows to the cliff face. The cliff erosion, due to wave action, will be managed by placing of sacrificial material on the beach at the toe of the cliff face. Hence, both causes of retreat will be reduced ensuring that the future rate of erosion is lower than the maximum 0.5m per year estimated in the Appendix 13.3 of the EIS.

We have conservatively estimated that the placement of the sacrificial material would reduce the maximum rate of erosion to 0.4m per year. The improved drainage will reduce this figure further again.

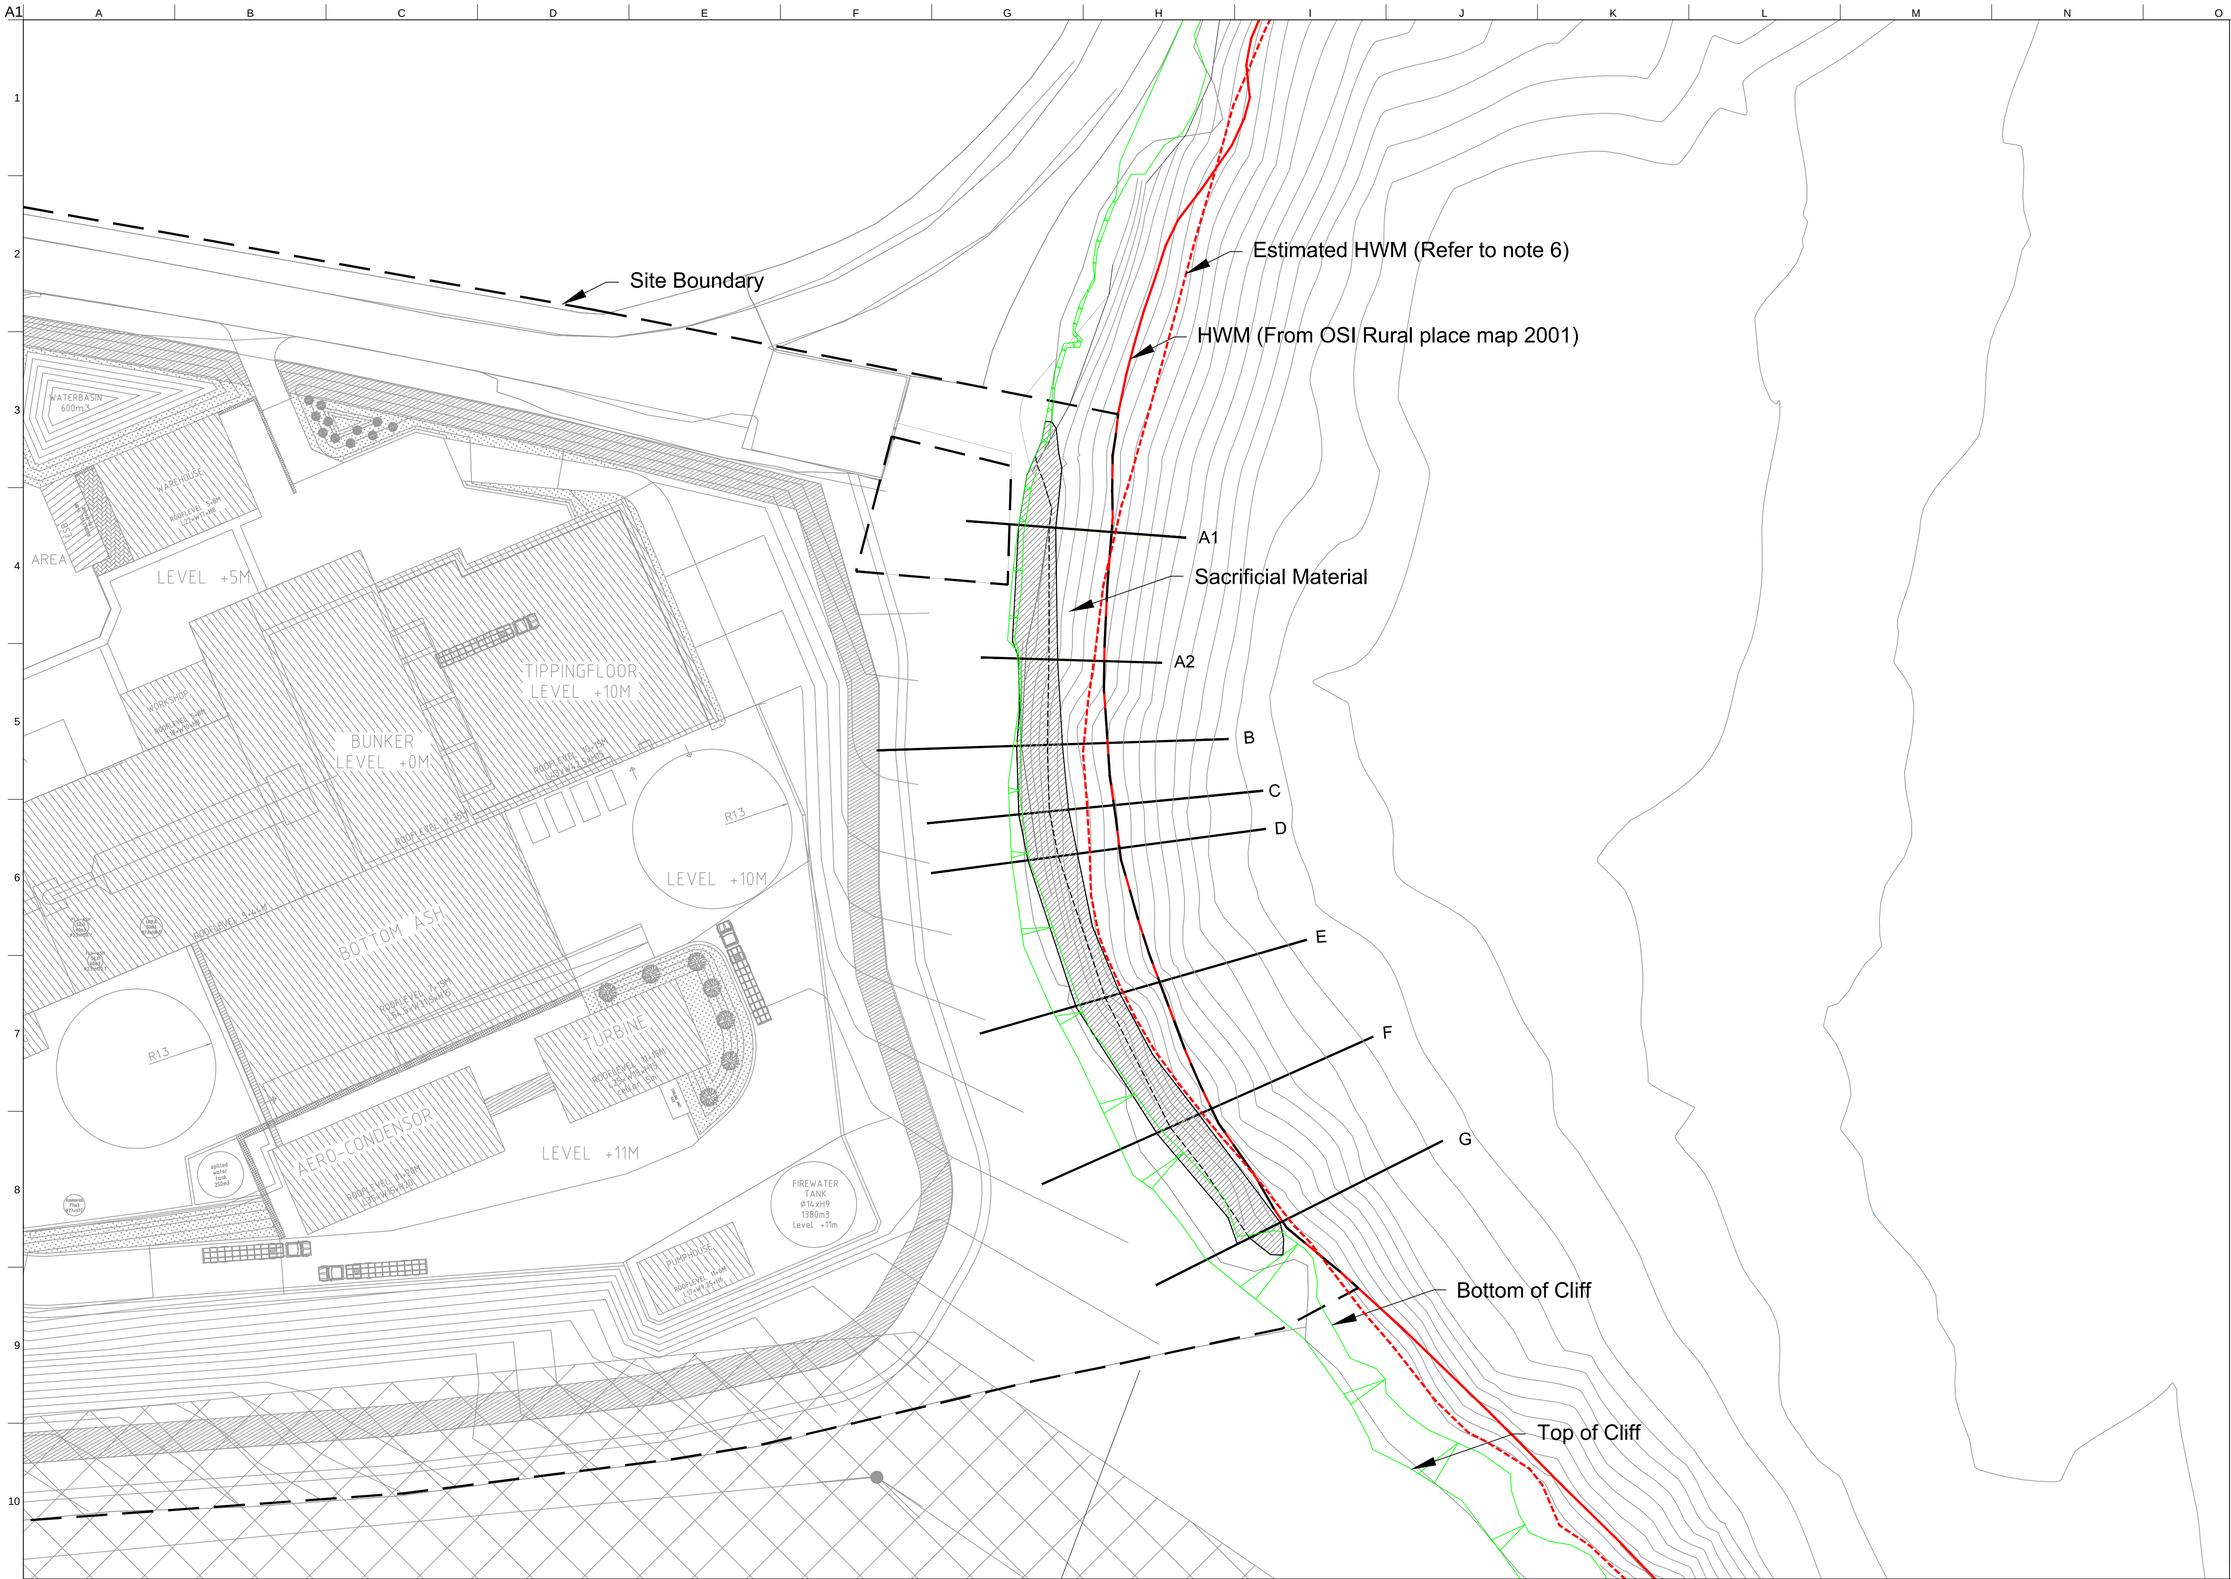
In reality the HWM changes constantly due to natural variations in the level and slope of the coastal areas. The HWM moves seawards and landwards for example during and between storm events). However, Ordnance Survey Ireland informed us that the HWM on the OSI map remains in the same position on each map revision. We will consult further with DoE before carrying out the works. If it concludes that that the proposed works might affect the foreshore as determined at the relevant time, then then the amount and position of the sacrificial material can be adjusted to remain above the HWM as shown in Appendix 1 of this document.

Appendix 1 shows an estimated current HWM with a reduced amount of sacrificial material above this HWM. The reduced amount would increase the frequency of application slightly, but this still falls within the impacts appraised within the EIS.

- As part of the coastal protection measures to reduce the rate of erosion it is proposed that the Indaver coastal boundary is monitored on an annual basis. In addition, approximately 1100m3 of sacrificial material (shingle) of appropriate size and shape (rounded) will be placed during the construction period. The material will be placed above the foreshore on Gobby beach along the eastern boundary of the Indaver site. Thereafter, it is proposed that the placement of further additional sacrificial material (shingle) is carried out if the glacial till slope erosion rate is more than 0.5m per year measured, over a period of six years, which would indicate some acceleration in the current erosion rate, or when the glacial till slope has retreated by approximately 3m, whichever occurs sooner.

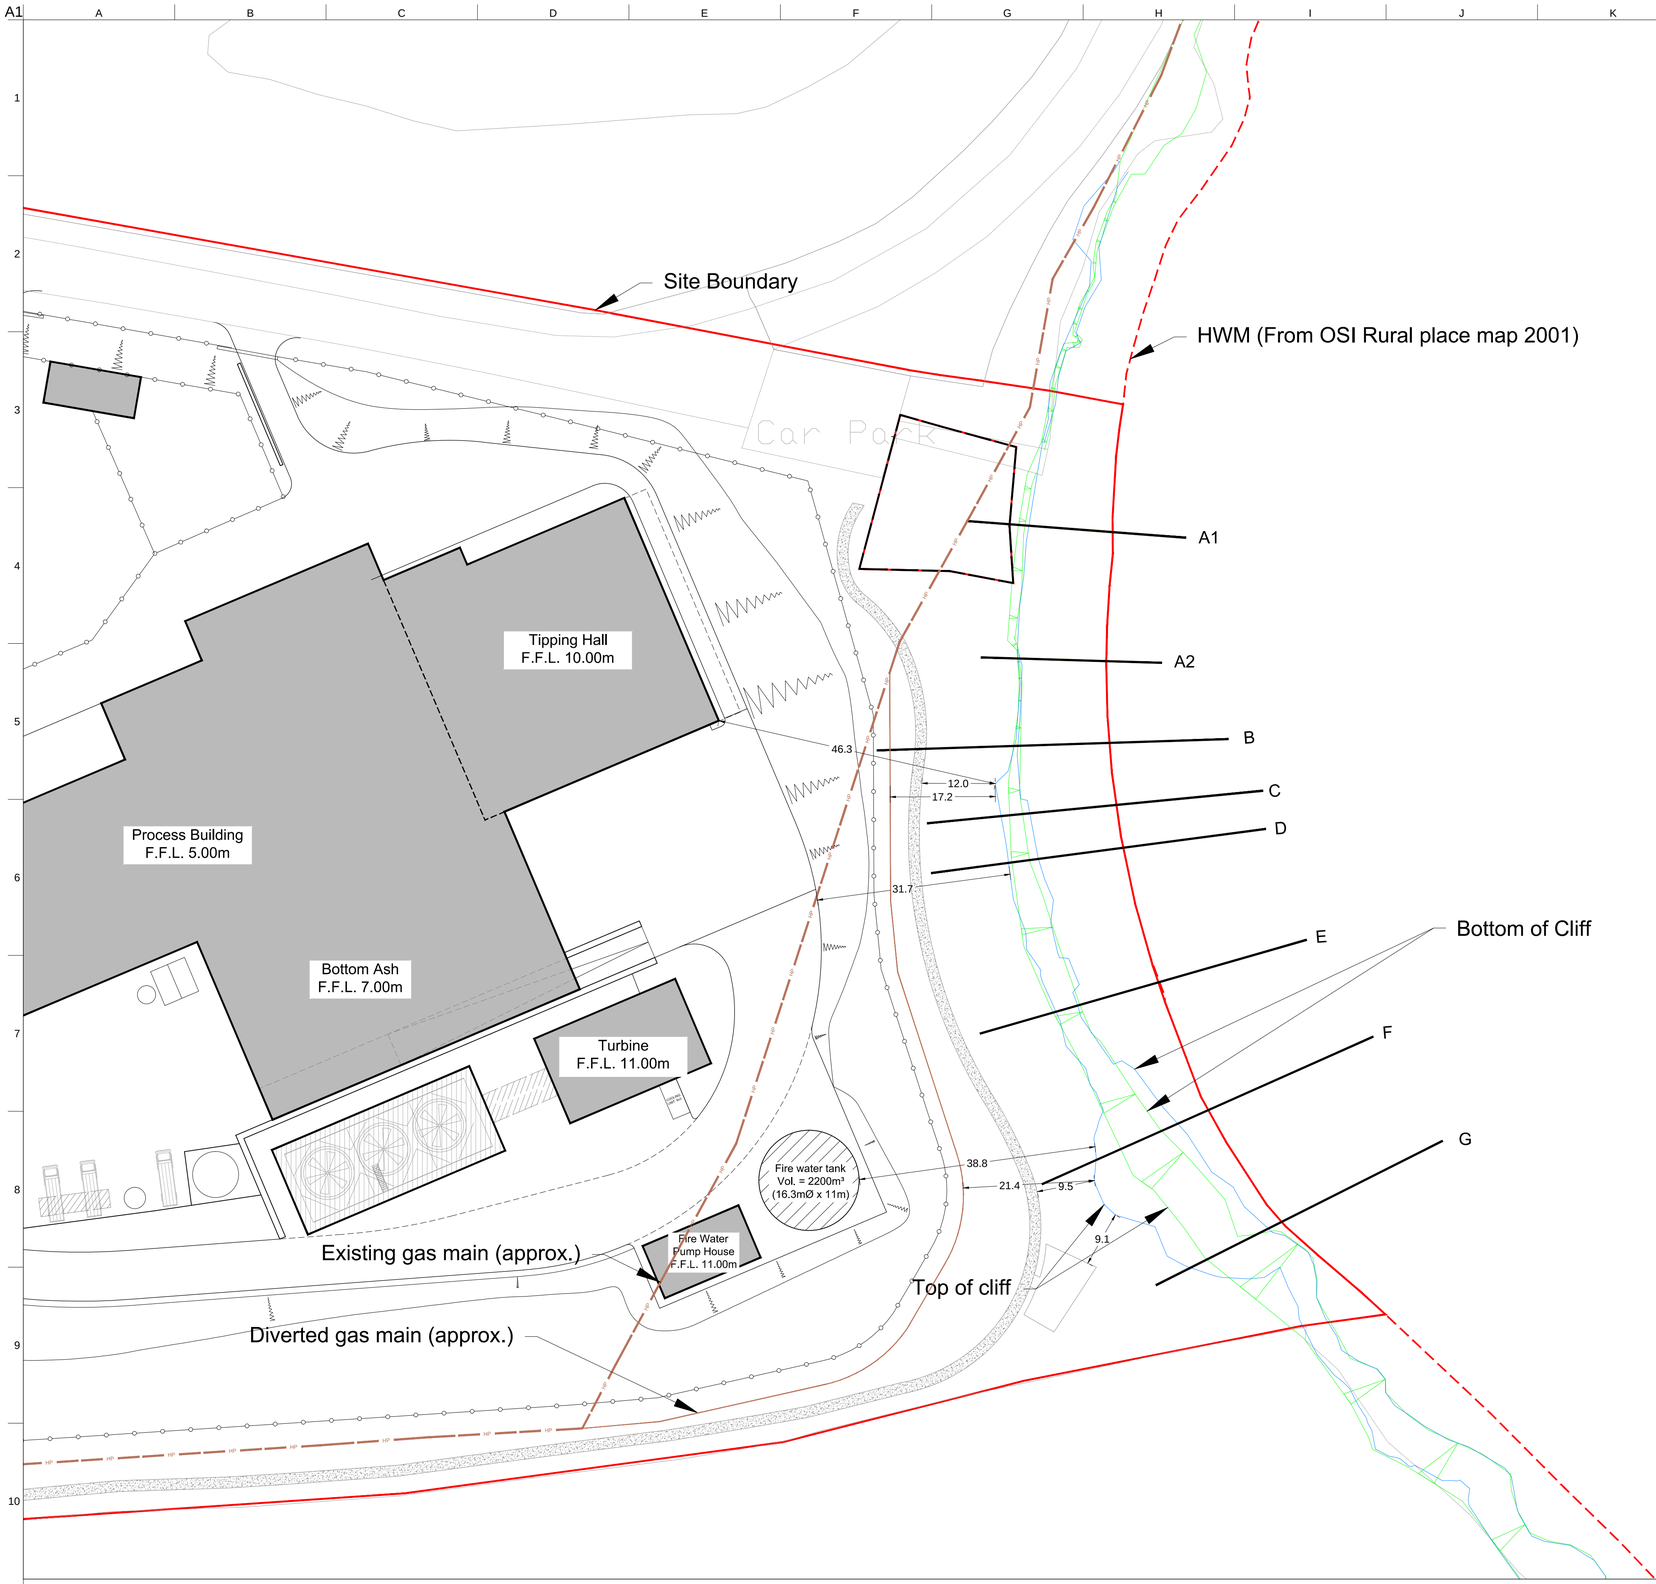
Response:
The estimation of coastal retreat following import placement of beach nourishment shingle has been provided in the EIS (see Appendix A of Appendix 13.3 of the EIS).
The minimum distance from the worst section of the current top of the cliff to the building is 46m. Distances to all other key elements are provided in the Appendix 2 of this document.
